Final Evaluation Report for Foundation Repair

Date: January 13, 2017
Attention: The Client
Subject: Foundation Review
123 Sample St., Fort Worth, Texas

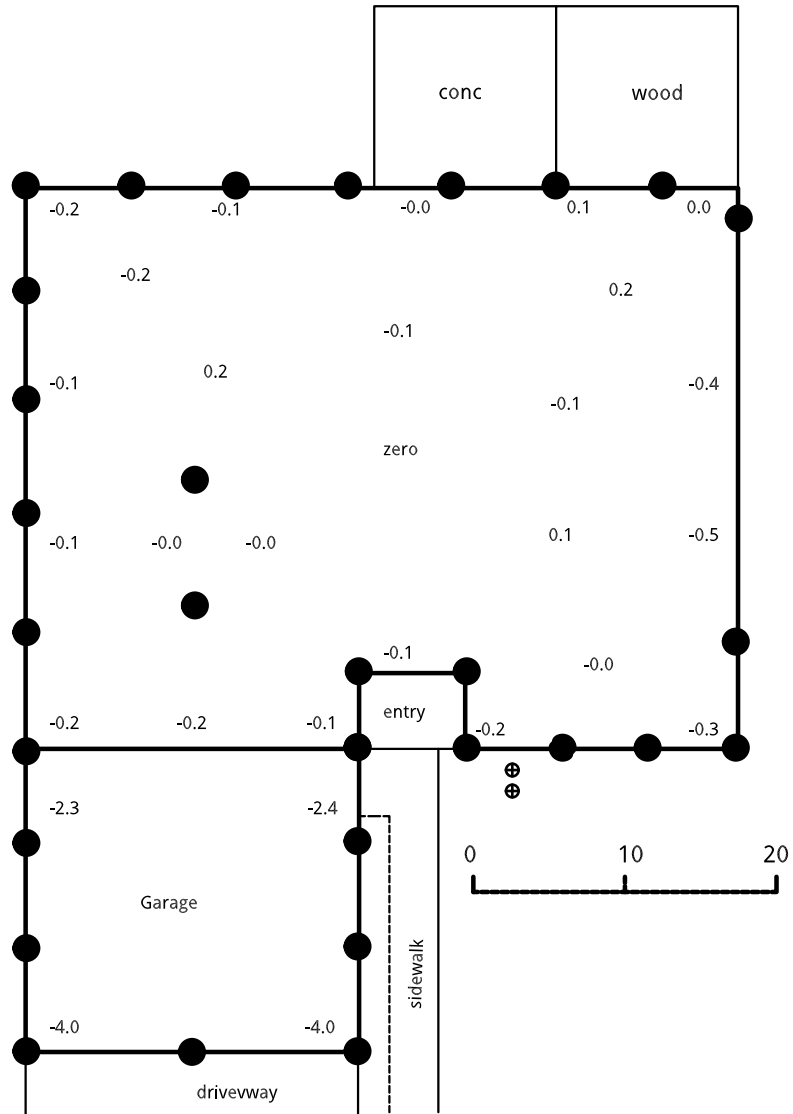
NEC performed a visual examination of the foundation for the subject property on 1/13/2017. NEC also performed a floor survey using a Zip-level Pro-2000 series, collecting relative floor elevations, to aid in surface topography mapping of the floor(s). Elevations shown are adjusted for the type of flooring encountered to reflect a consistent measuring plane. The map of the post-lift floor elevations can be seen in the figure attached to this report.

Based on the data gathered and our professional engineering opinion, the repairs performed by the Contractor have improved the foundation to be within slope tolerances generally accepted as industry standards.
