Initial Report for Foundation Assessment

Date: January 13, 2017
Attention: The Client
Subject: Foundation Review
123 Sample St., Fort Worth, Texas

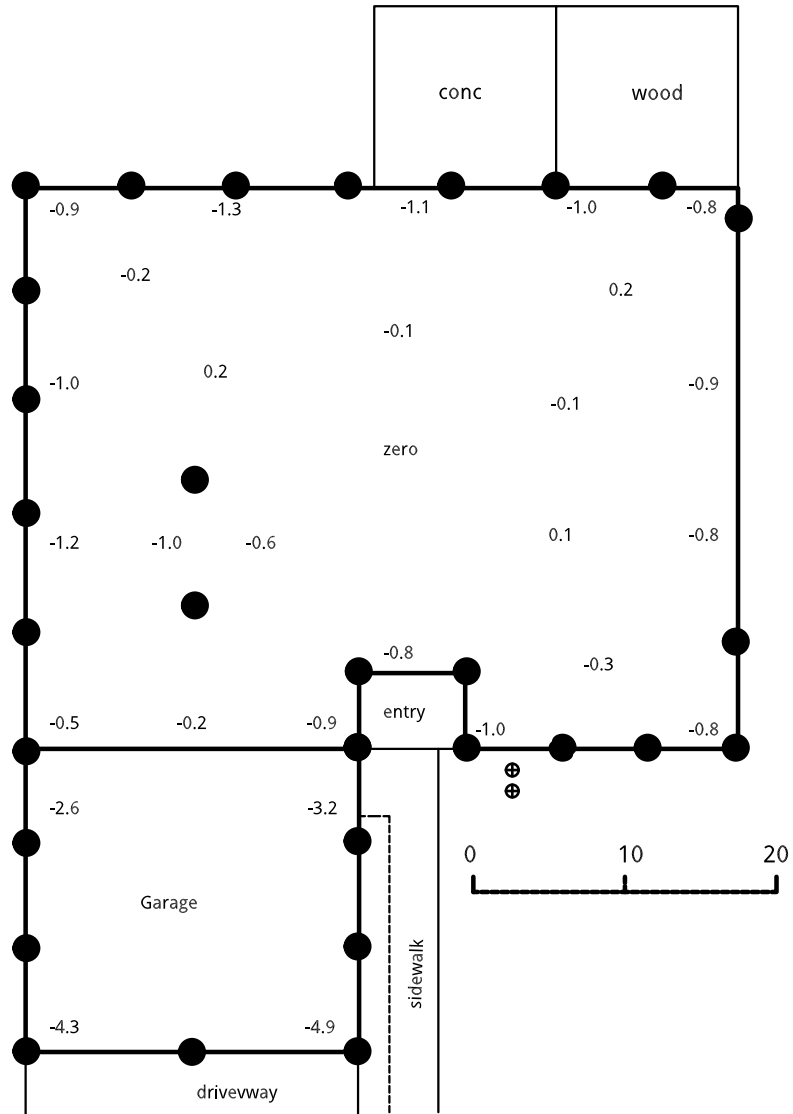
NEC performed a visual examination of the foundation for the subject property on 1/13/2017. NEC also performed a floor survey using a Zip-level Pro-2000 series, collecting relative floor elevations, to aid in surface topography mapping of the floor(s). Elevations shown are adjusted for the type of flooring encountered to reflect a consistent measuring plane. The map of the existing floor elevations can be seen in the figure attached to this report.

Based on review of the foundation, and reasonable professional engineering opinion, we've determined that settlement of the foundation has occurred and should be repaired. Although complete levelness cannot be guaranteed, or may not be attainable, the proposed plan should improve the performance of the foundation. **It is recommended that twenty-one (21) piers be installed as indicated on the figure(s) attached to this report.** Locations of internal piers [if needed] are intended to be approximate. The Contractor should locate the beams and place internal piers accordingly. **Furthermore, the proposed foundation repairs shall meet or exceed the 2015 International Residential Code (IRC) and any local applicable amendments to the IRC.**
